# PLANETARY VEHICLE THERMAL INSULATION SYSTEMS

## FINAL REPORT

JET PROPULSION LABORATORY

UNDER JPL CONTRACT NO. 951537

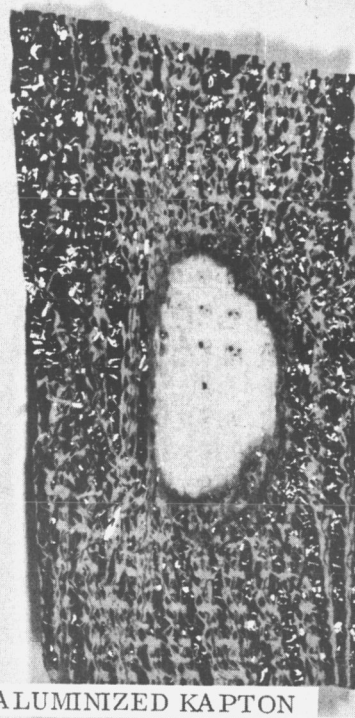
Figure 2-8. Water Vapor Exposure Results

Figure 2-8 depicts the extensive removal of aluminum from the plastic films when exposed to a water vapor atmosphere. The figure shows circular areas devoid of aluminum representing the shape of the test beaker rim. The presence of a visually transparent  $\text{Al}_2\text{O}_3$  film could not be detected. Gold on Mylar exhibited no adverse effects to the same exposure.

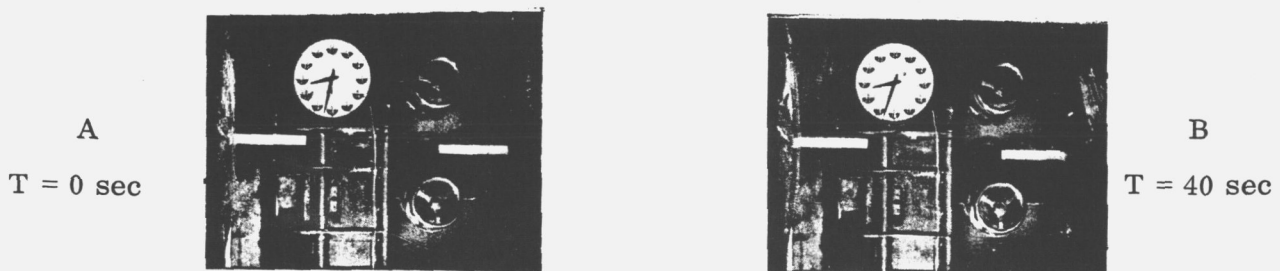
Figure 2-31. Film Segment-Depressurization Test

An x-y plotter was used to record air lock pressure versus time with the desired pressure profile being preplotted on the x-y chart paper. Test chamber lights, clock, camera and x-y plotter were all connected to a single control switch, and their operations synchronized. Figure 2-31 shows portions of a test film: Part A shows no deflection at  $T=0$ , and Part B shows expansion about half-way through the depressurization period.

The support frame for the second series of depressurization tests is shown in Figure 2-33. "Tinger" fasteners, developed during this program, were used to mount the blankets in the frame. The Tinger fastener, shown in Section YY of Figure 2-31, consists of an approximately 1/4 inch diameter Nylon mast, undercut at the top to accept a retainer washer. One inch diameter Velcro "hook" material is cemented to the mast base. A corresponding square patch

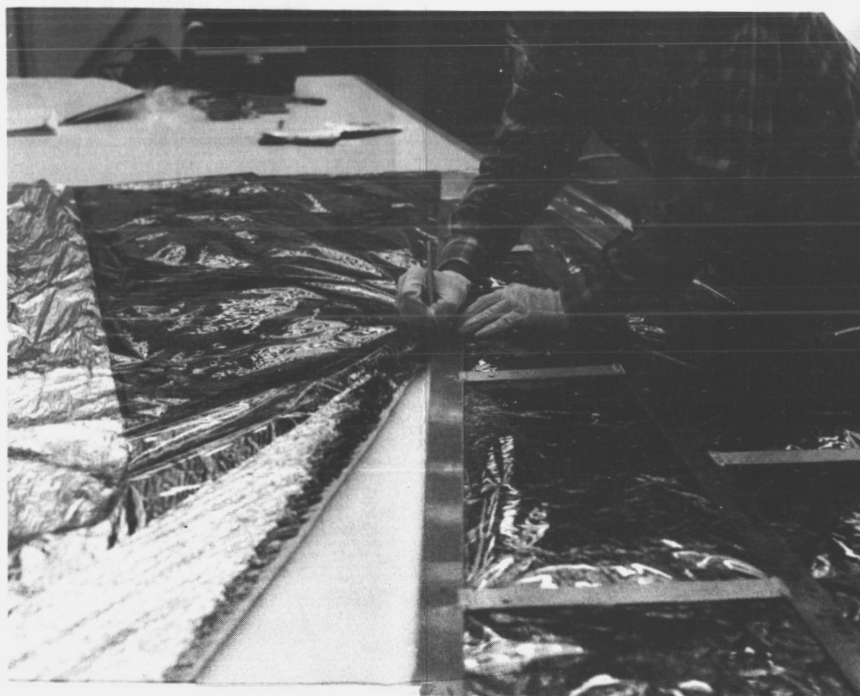
Figure 2-86. Fabrication

Metal templates were made of the desired blanket profile and penetrations. The mounting holes, into which the Tinger mounting posts were placed, were also located by the templates. A cover sheet of 2 mil Kapton was placed on top of the lay-up of insulation material on the table. The metal template was placed on top and clamped to the table. An X-acto knife was used to cut the blanket to shape, using the metal sides of the template to guide the blade (Figure 2-86 depicts this operation). The use of Tinger fasteners, employing 2 by 2 inch Velcro "pile" cemented to the spacecraft, eliminate the requirement for precise location of mounting holes. The spacecraft skin is not penetrated for mounting. Tingers provide several other advantages: namely, the need for blanket stitching is eliminated, blanket removal is facilitated without need for disturbing other blankets, ease of alignment permits better fit-up, and blanket installation on the vehicle is simplified.

Figure 2-90 is a block flow diagram of the test vehicle movement prior to and following the thermal vacuum tests. Basically, the capsule and spacecraft were moved from the assembly area to the preparation area adjacent to the test chamber. Figure 2-86, of Subsection 2.5.2, shows the fixture during preparation. Heaters, thermocouples, insulation and instrumentation were installed and checked out. After installation in the test chamber, the system was pumped down, the tests performed and the chamber warmed up and vented. Post-test, the insulated test fixture was removed from the chamber and returned to the preparation area for visual observation.
